Excerpts from AMSAA's M109A6 Paladin Starter Motor Corrosion Analysis

For the 2010
U.S. Army Corrosion Summit
February 9-11, 2010

Brian E. Frymiare
U.S. Army Materiel
Systems Analysis Activity

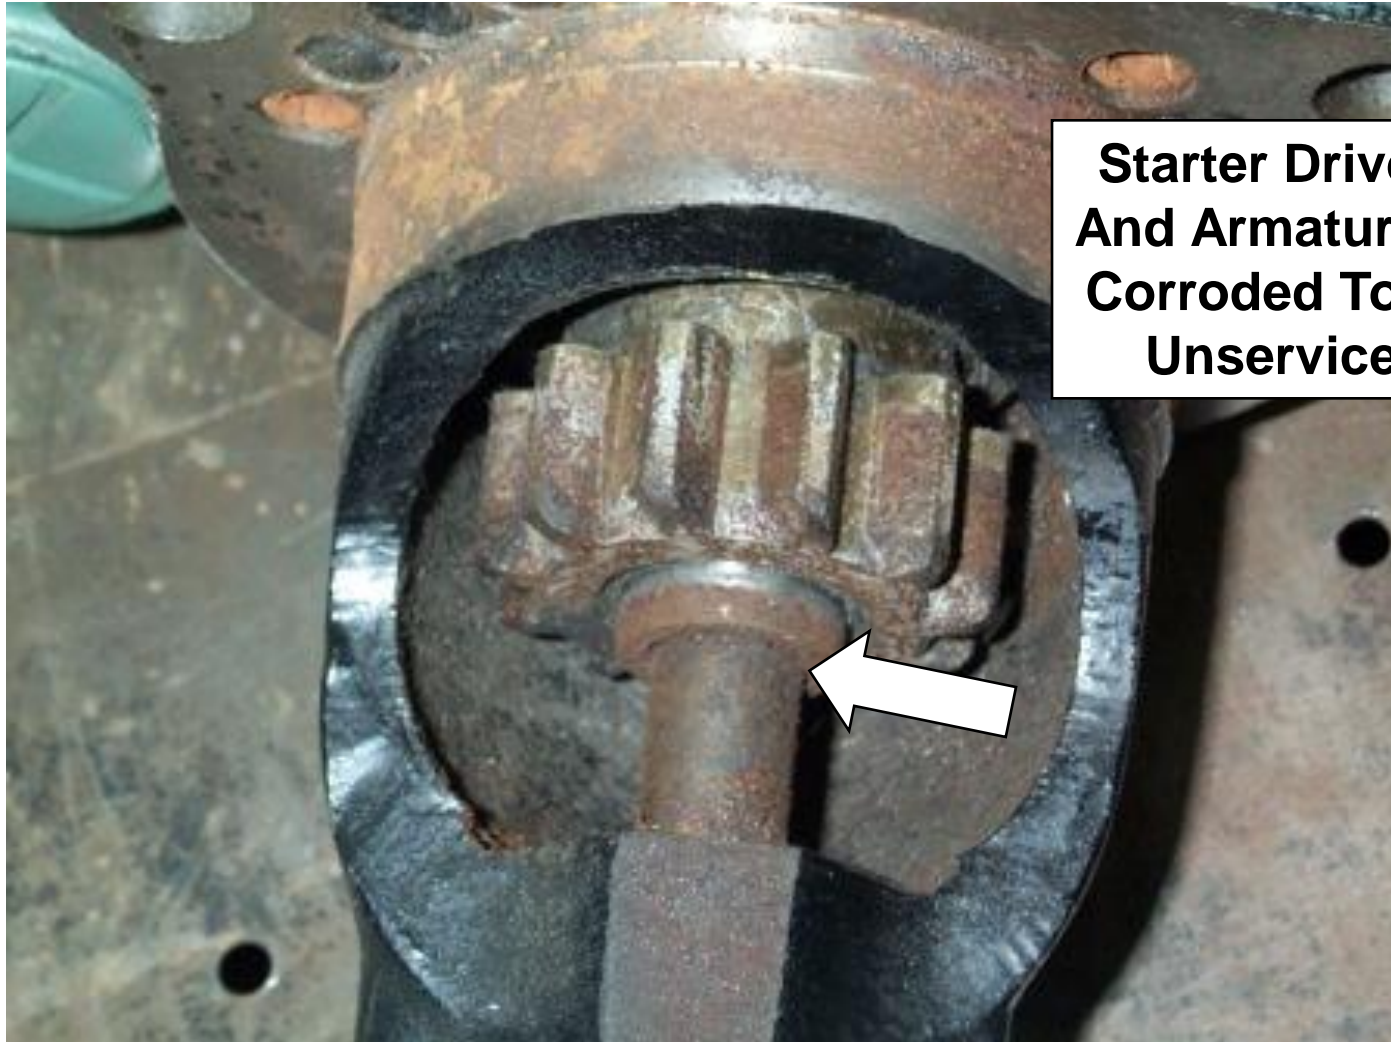
Failed M109A6 Starter

The Failure Mode was Excessive Corrosion

The Corrosion Rendered the Starters Inoperative

**Starter Drive Gear
And Armature Shaft
Corroded Together
Unserviceable**

Despite the New Manufacturer stating that their Starter Motor Shaft's Utilized a Protective Zinc Plating, **NO** Zinc was Found on the Armature Shaft Analyzed.

Lack of a Protective Coating Undoubtedly Led to the High Rate of Starter Motor Failures

It was Recommended that any New Existing Starter Motors not be Utilized, and Starters Already Utilized be Recalled and Destroyed

That for Future Starters, the Starter Armatures Material be Changed to Stainless Steel (Commercial Practice)

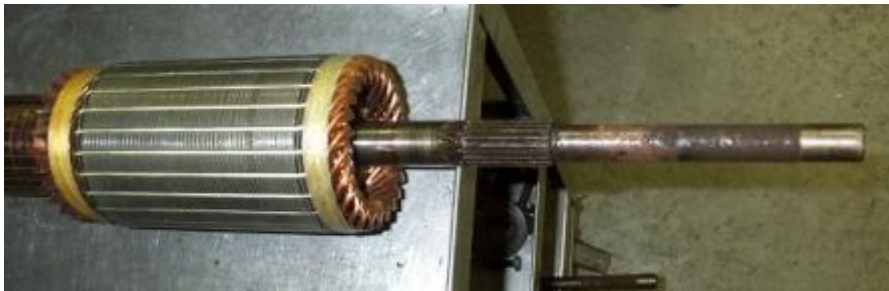
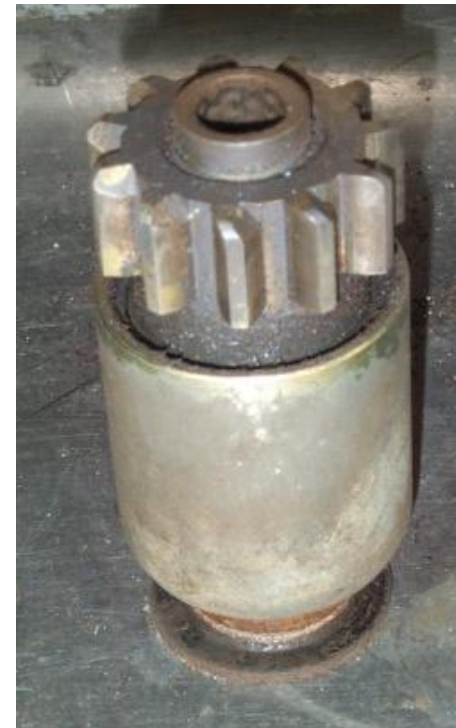
Two Starter Motors (One from Each Manufacturer) were Analyzed.

A **Thorough** Material Analysis was Conducted on the Starters

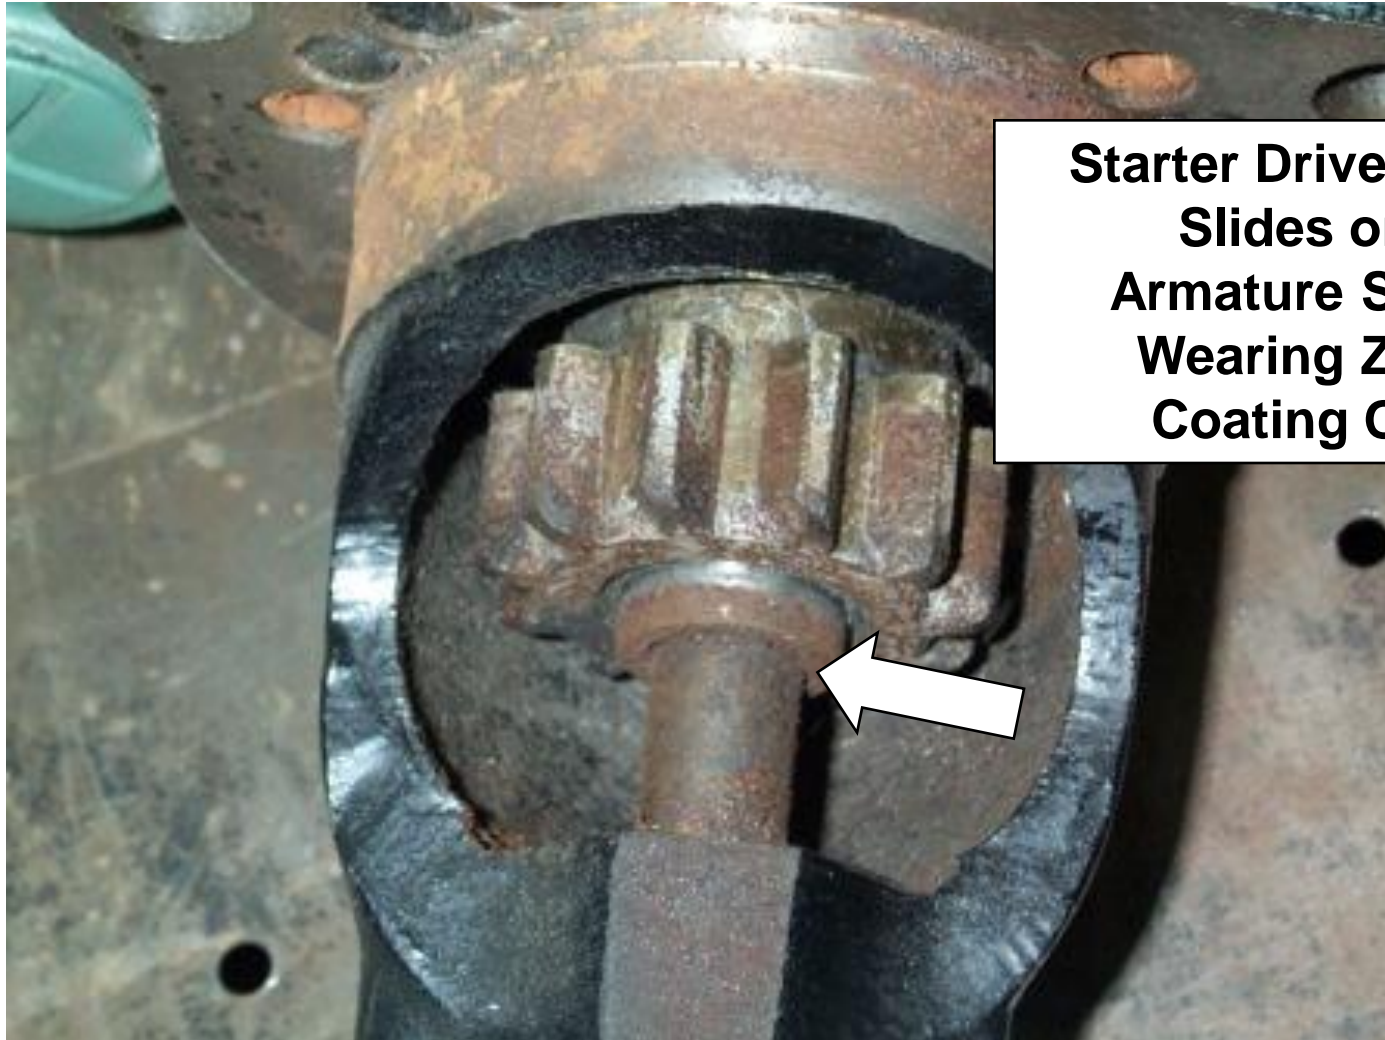
Failed M109A6 Starter

Corrosion was Starting on the Original Starter, Where the Starter Drive Gear Slides on the Armature Shaft – Wearing the Protective Zinc Coating Off

**Starter Drive Gear
Slides on
Armature Shaft
Wearing Zinc
Coating Off**

It was Recommended that all Starter Motors be Exercised During Salt Water Spray Corrosion Testing, and the Test Procedure be Changed so that any Similar Items be Exercised During Salt Water Spray Corrosion Testing

- Conduct 24 Hours of Salt Spray Testing
- Utilize Test Item for 40 % of its Life Cycle
- Conduct an Additional 24 Hours of Salt Spray Testing
- Utilize Test Item for an Additional 40 % of its Life Cycle
- Conduct an Additional 48 Hours of Salt Spray Testing
